Hollow Home Inspections LLC

Home Inspection Report

3091 Rock Creek Rd

Inspected on Mon, Jun 17 2019 at 3:05 PM

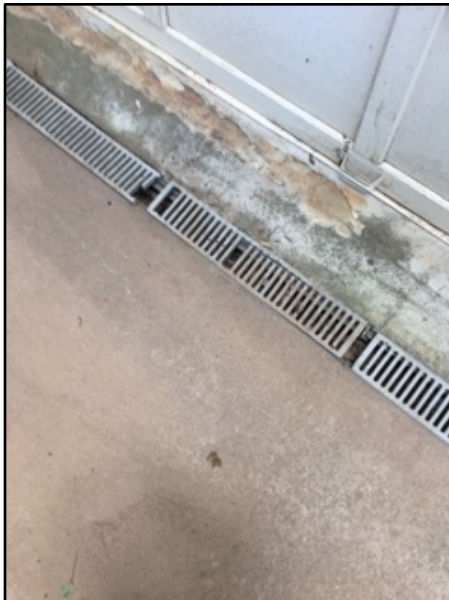
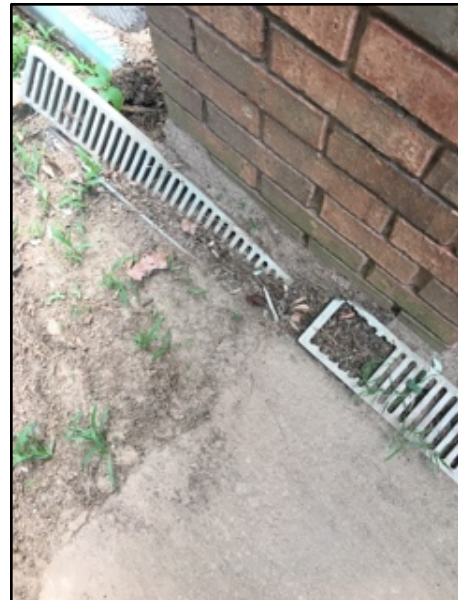
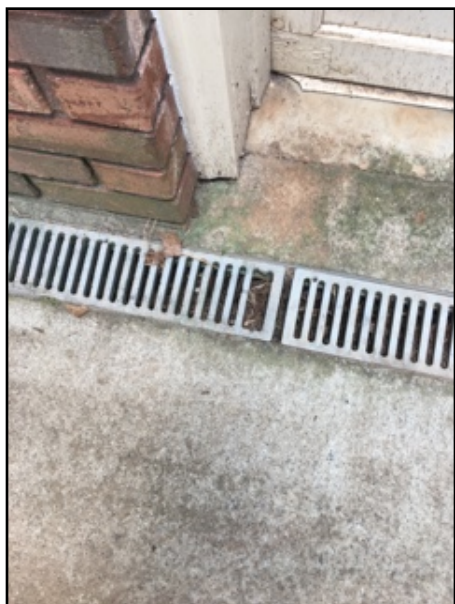
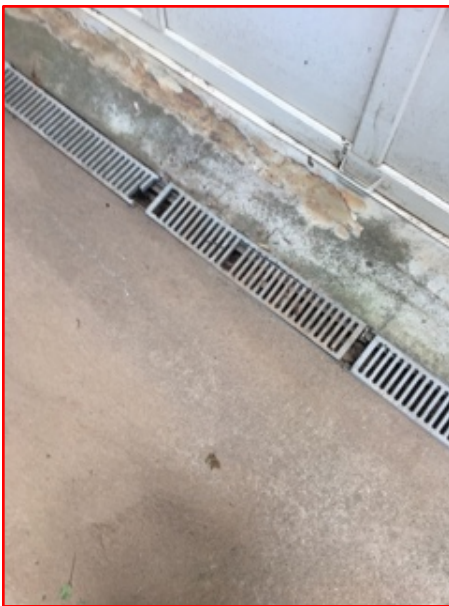
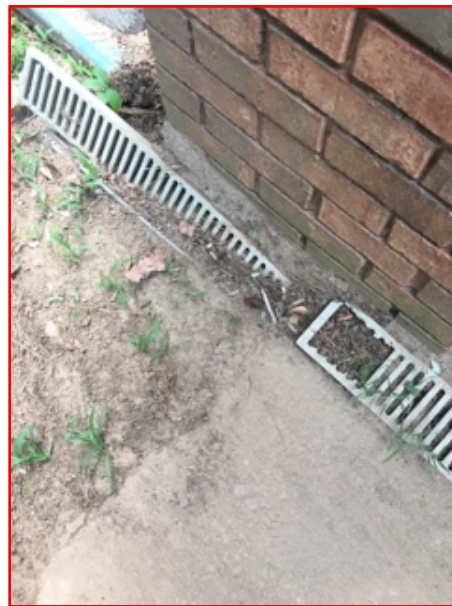
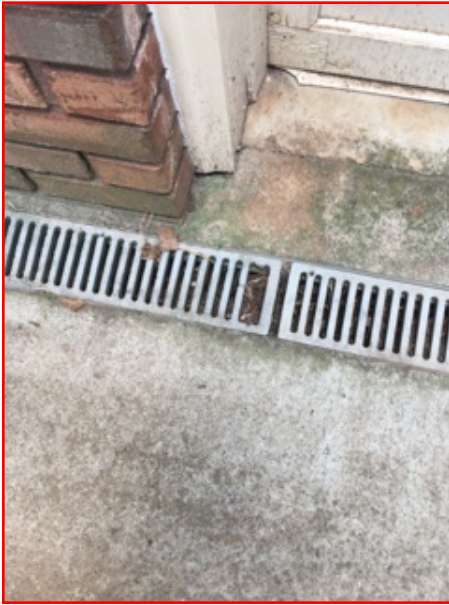
French Drains are clogged and need to be removed of all debris in order to properly excavate water away from the garage .

1) French Drains are clogged and need to be removed of all debris in order to properly excavate water away from the garage .

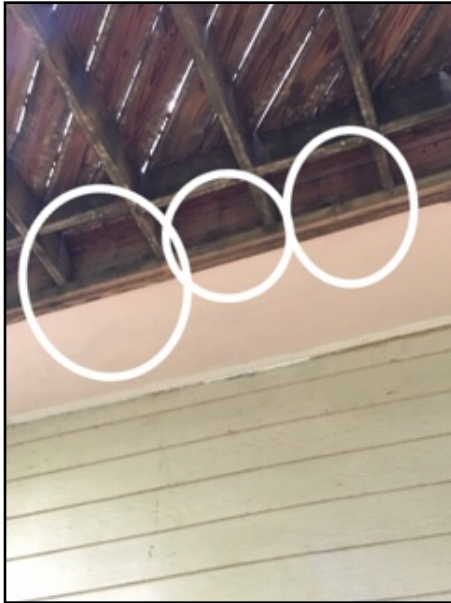
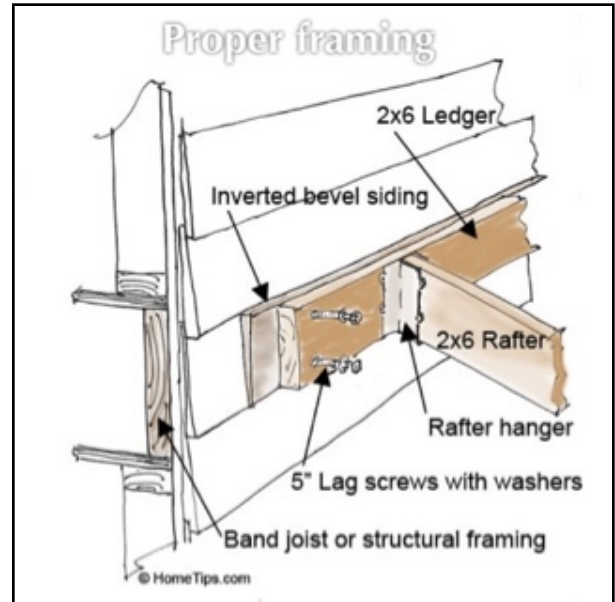
The Balcony was installed improperly/ Not properly secured to the structure which can cause it to collapse. Recommend repairing/ reframing by a licensed professional contractor.

4) The Balcony was installed improperly/ Not properly secured to the structure which can cause it to collapse. Recommend repairing/ reframing by a licensed professional contractor.

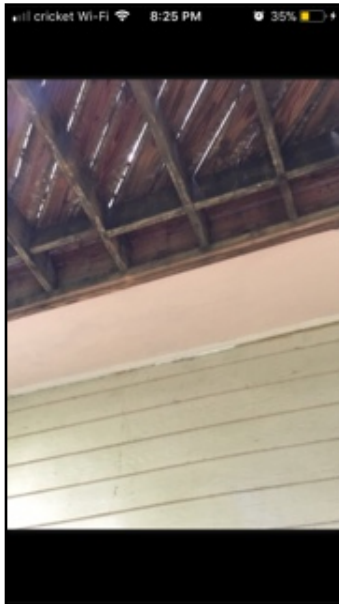
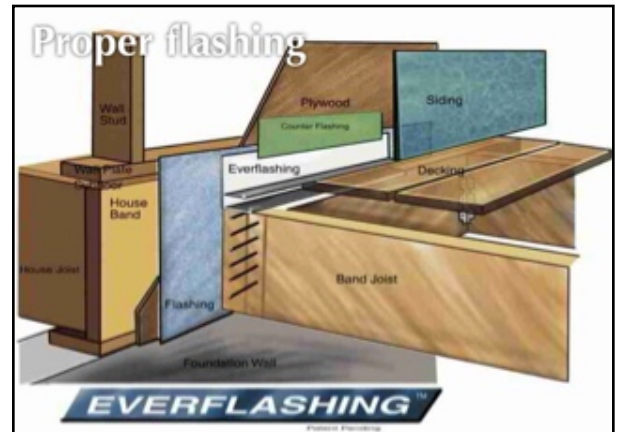
The Balcony is improperly flashed along the ledger board. Recommend proper flashing installation by a professional contractor.

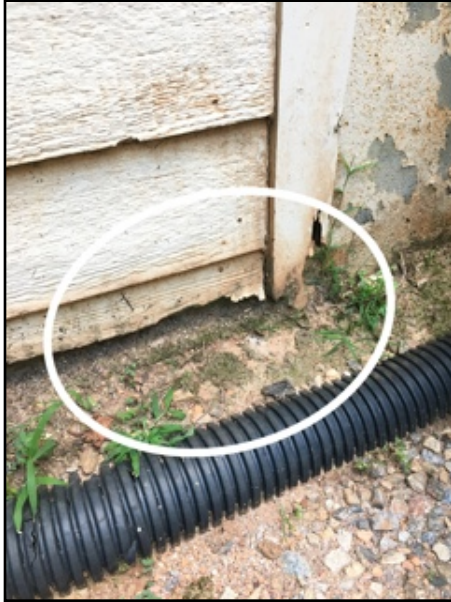
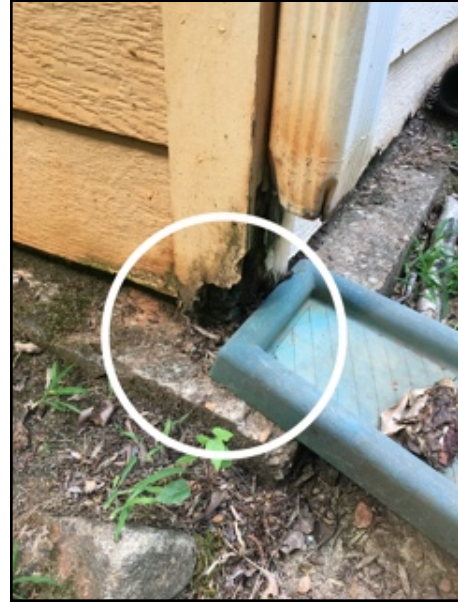
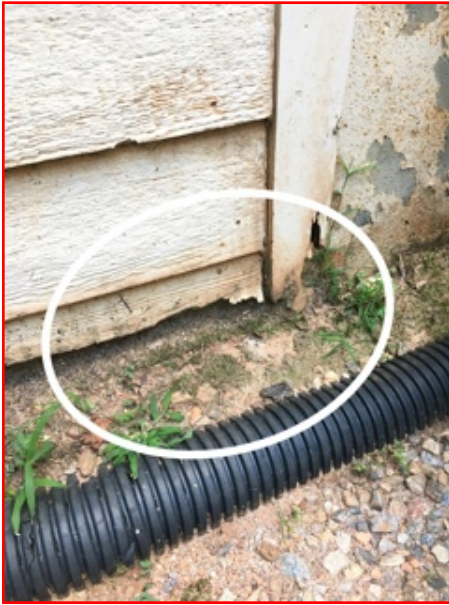
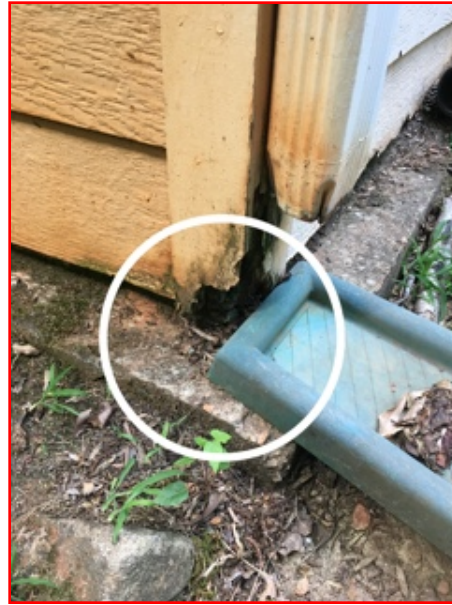
The exterior trim shows signs of deterioration. Recommend monitoring for further damage.

10) The exterior trim shows signs of deterioration. Recommend monitoring for further damage.

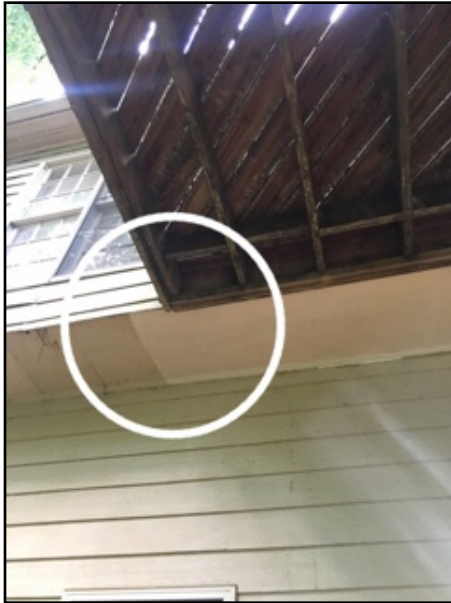
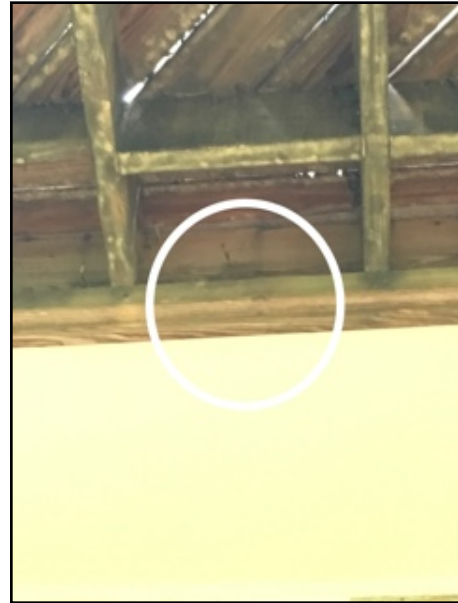
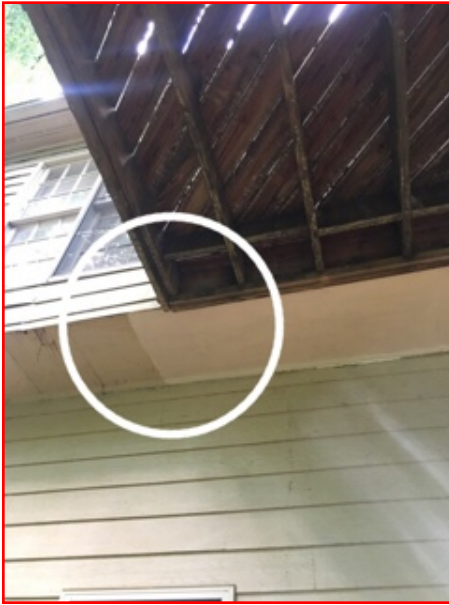
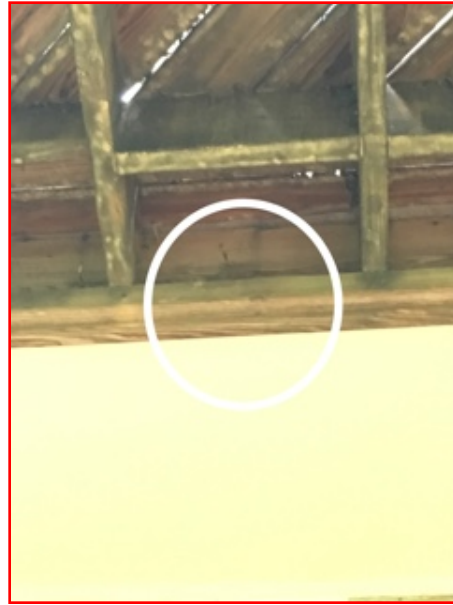
Balcony is improperly Installed & secured to structure. Nails were used to attach the Balcony to the structure which is unacceptable; This is a Hazard, recommend proper installation and securing by professional contractor.

12) Balcony is improperly Installed & secured to structure. Nails were used to attach the Balcony to the structure which is unacceptable; This is a Hazard, recommend proper installation and securing by professional contractor.

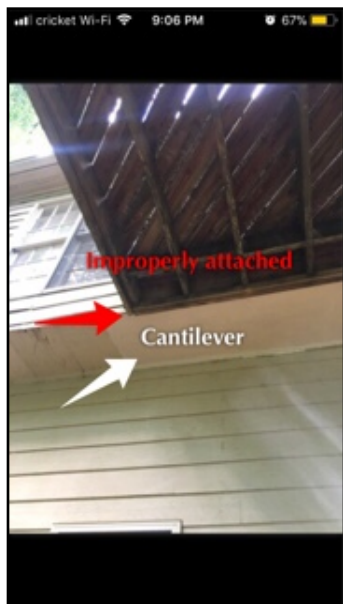
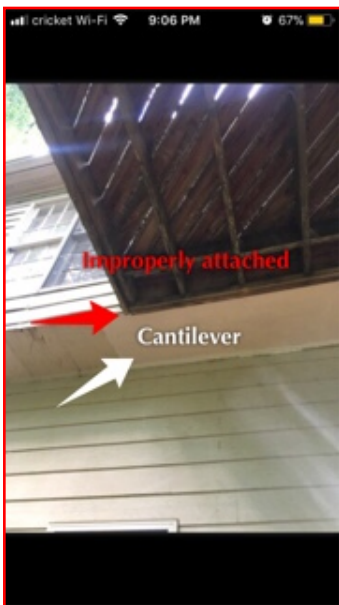
Balcony is improperly attached to structures cantilever (Overhang). Attaching a Deck to a cantilever is improper. Recommend proper installation of post near the house by a professional contractor.

13) Balcony is improperly attached to structures cantilever (Overhang). Attaching a Deck to a cantilever is improper. Recommend proper installation of post near the house by a professional contractor.

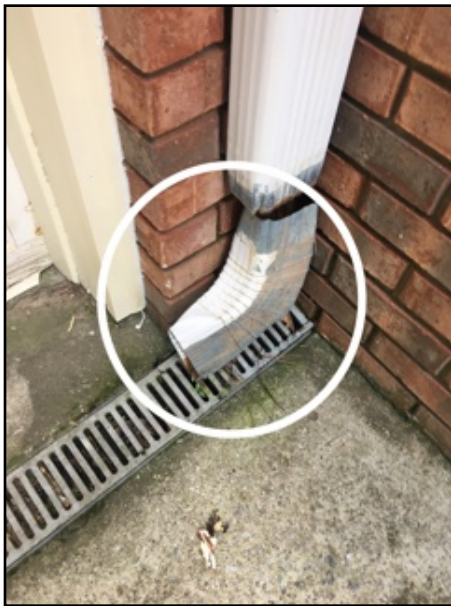
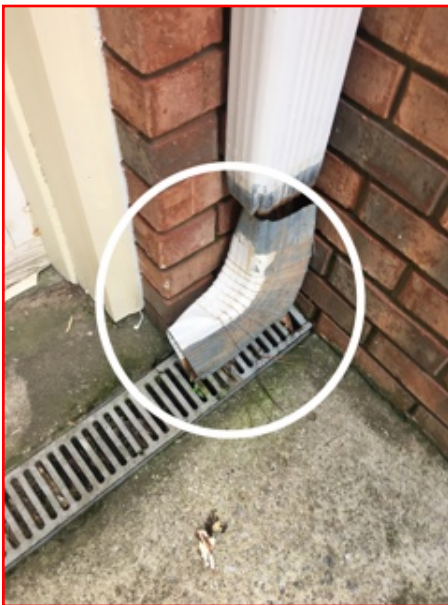
The gutter is damaged & downspout terminals are pinched closed. Downspouts are needed in order to properly excavate water from the foundation

18) The gutter is damaged & downspout terminals are pinched closed. Downspouts are needed in order to properly excavate water from the foundation

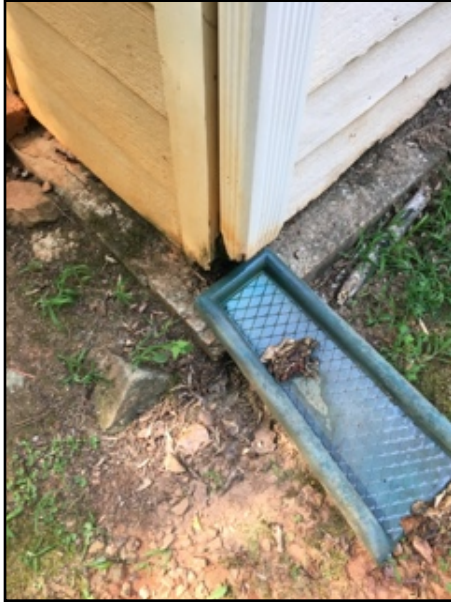
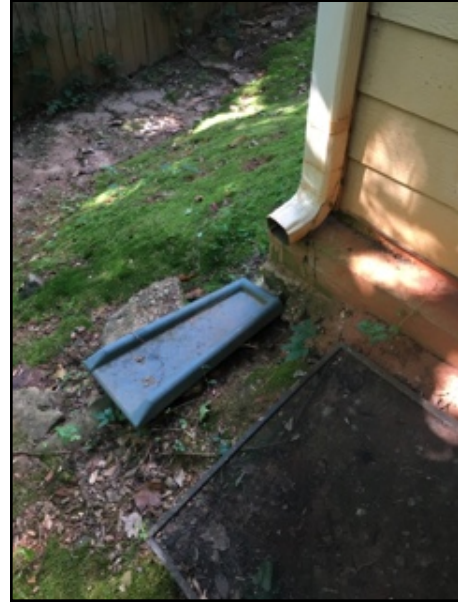
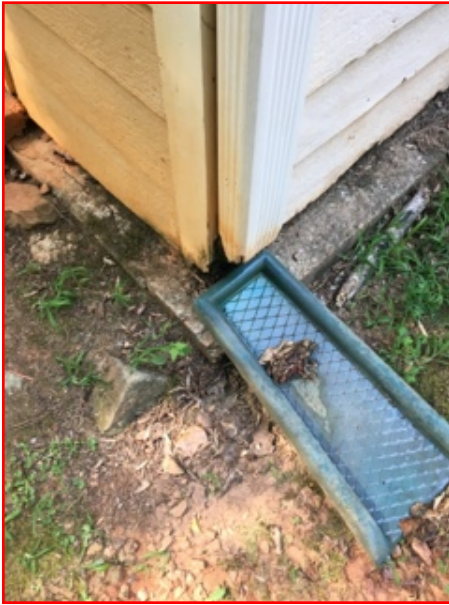
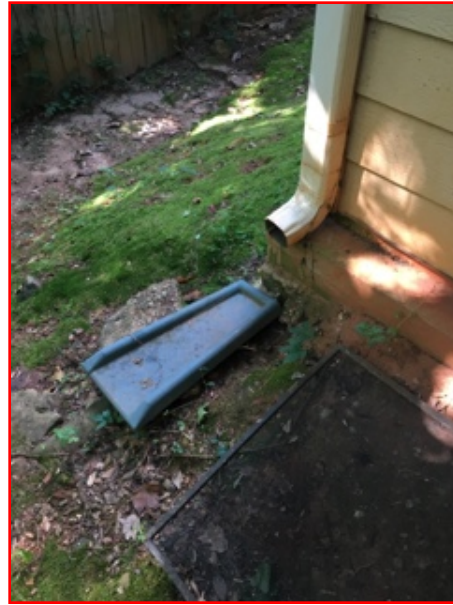
The gutter downspout terminals are missing. Splash blocks aren't efficient to continuously excavate water away from the foundation.

19) The gutter downspout terminals are missing. Splash blocks aren't efficient to continuously excavate water away from the foundation.

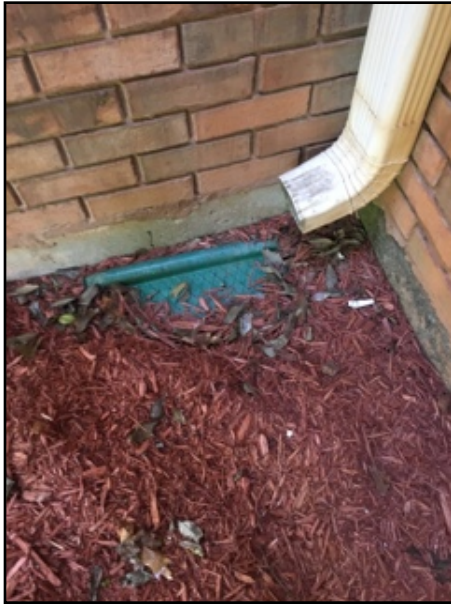
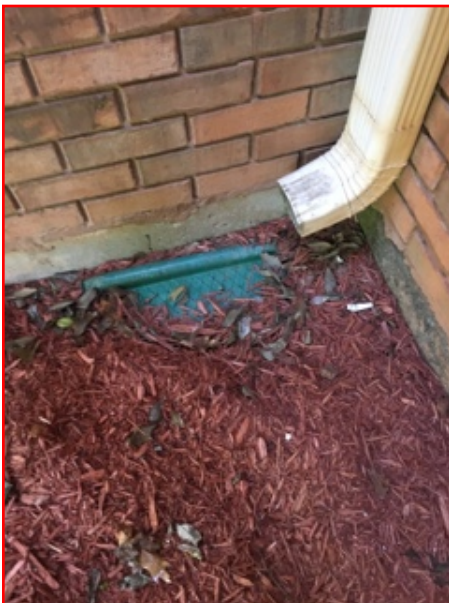
The downspout needs an extension. Also exhibited signs of water puddling during inspection which was sloping towards the foundation wall. Recommend installation of downspout termination extensions.

20) The downspout needs an extension. Also exhibited signs of water puddling during inspection which was sloping towards the foundation wall. Recommend installation of downspout termination extensions.

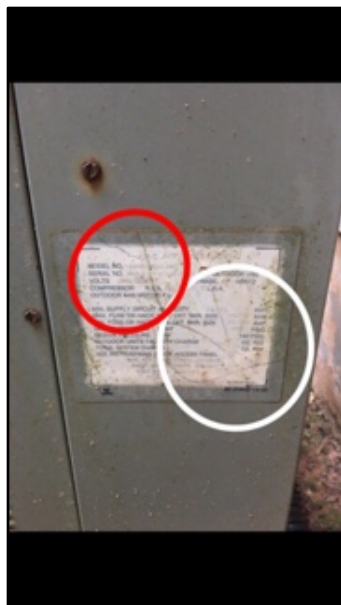
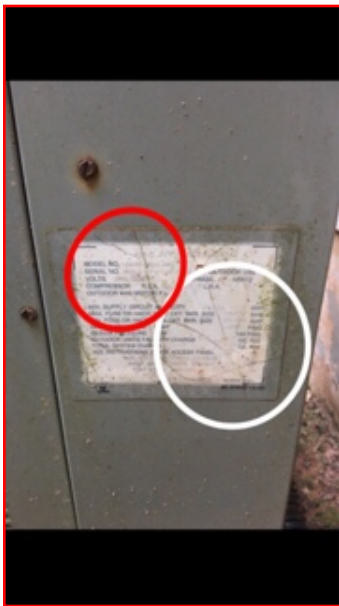
Comment 26:
Equipment serial number wasn't legible to certify Btu's and Age of Unit.

26) Equipment serial number wasn't legible to certify Btu's and Age of Unit.

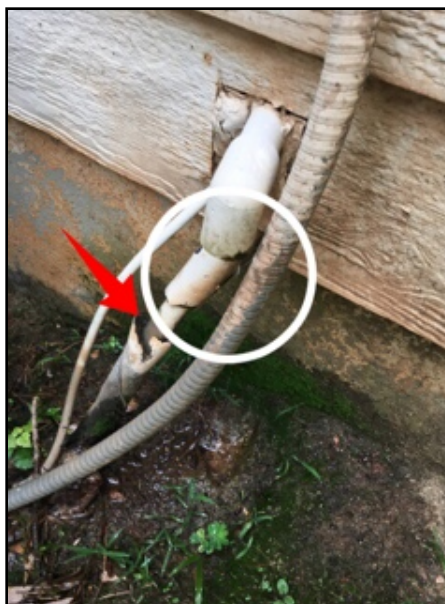
The Unit's Wiring have exposed sheathing and the condensate line is continuously dripping water onto it. Recommend sheathing be installed to avoid any electrical damage.

27) The Unit's Wiring have exposed sheathing and the condensate line is continuously dripping water onto it. Recommend sheathing be installed to avoid any electrical damage.

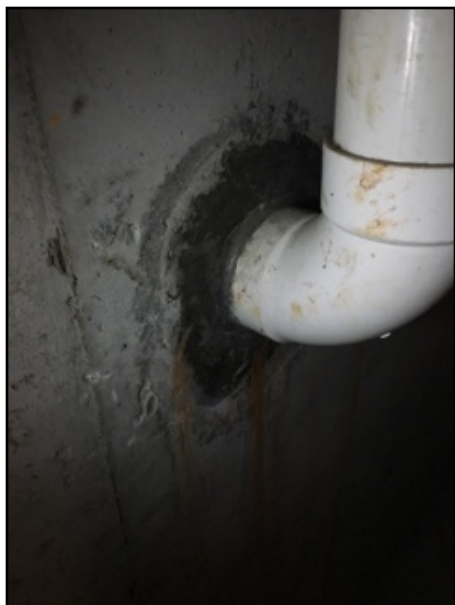
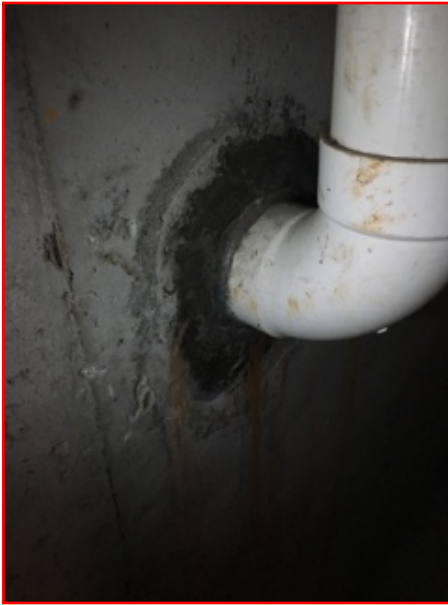
Waste pipe is exhibiting signs of previous leakage seems to have been recently caulked recommend monitoring for further leaking.

28) Waste pipe is exhibiting signs of previous leakage seems to have been recently caulked recommend monitoring for further leaking.

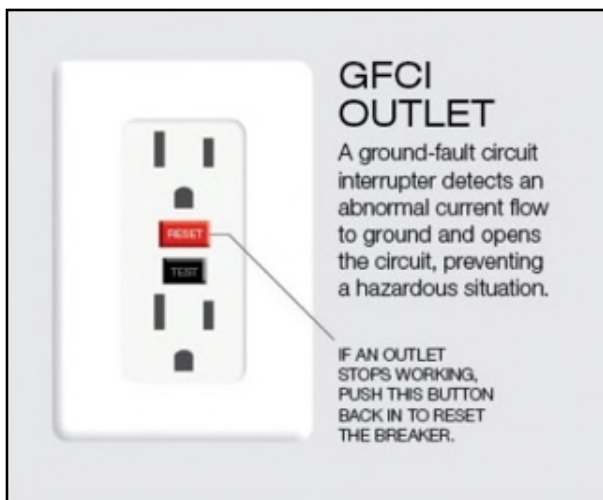
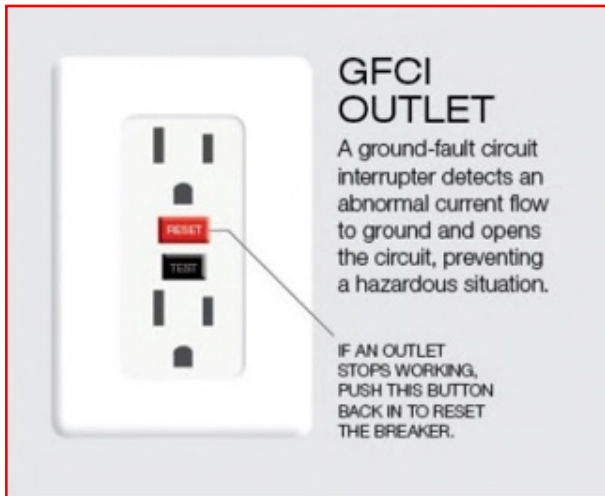
Comment 31:
Recommend upgrading to Gfci outlets with test and trip buttons in all bathrooms and Kitchen .

31) Recommend upgrading to Gfci outlets with test and trip buttons in all bathrooms and Kitchen .

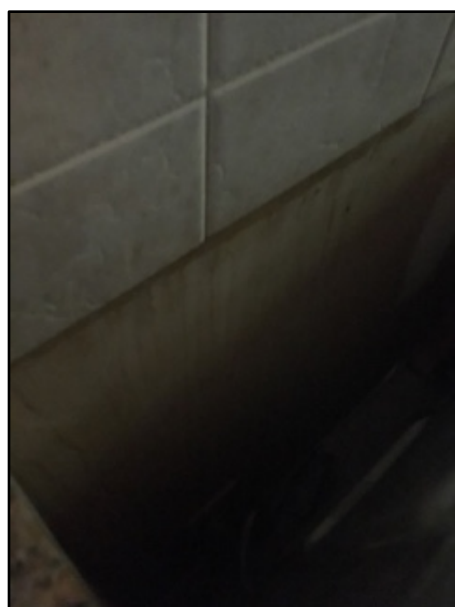
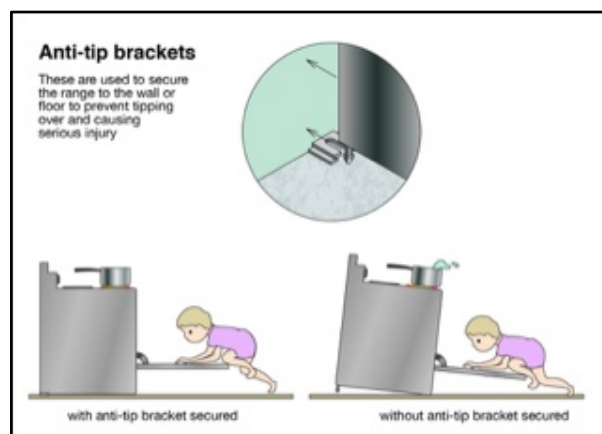
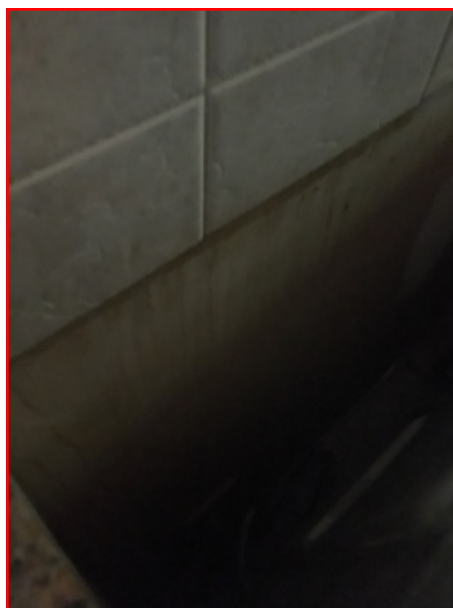
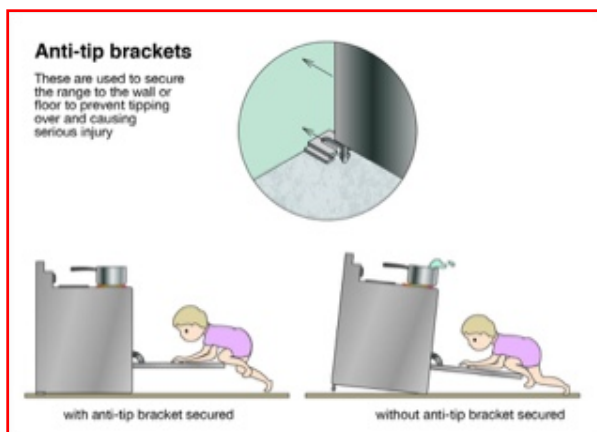
Comment 32:
Range is missing Anti Tip brackets. Recommend having Anti-tip brackets installed.

32) Range is missing Anti Tip brackets. Recommend having Anti-tip brackets installed.

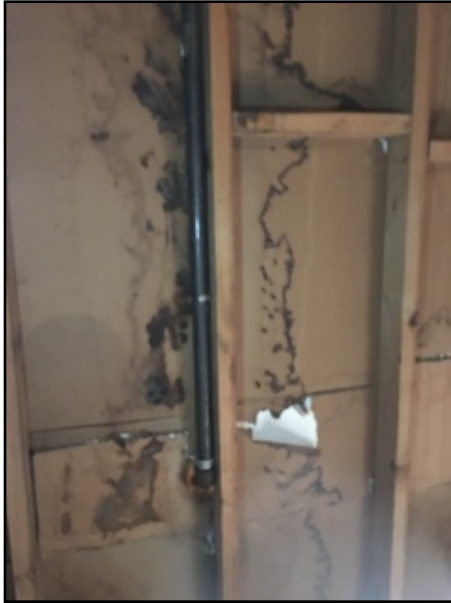
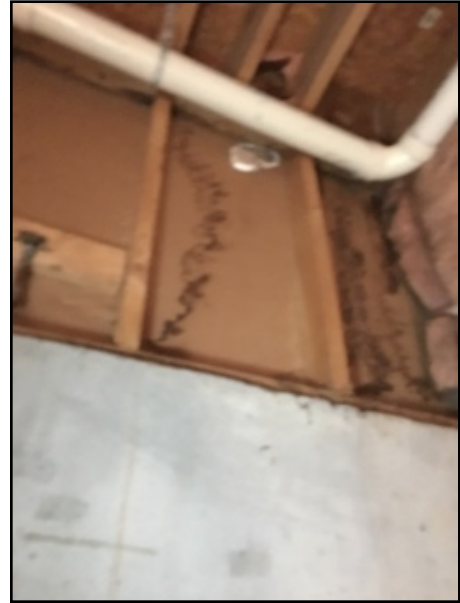
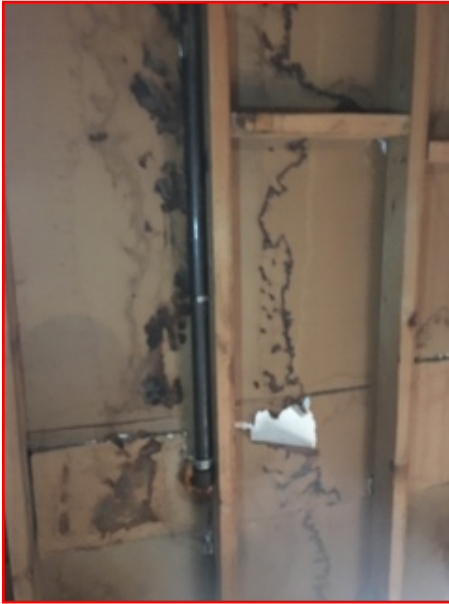
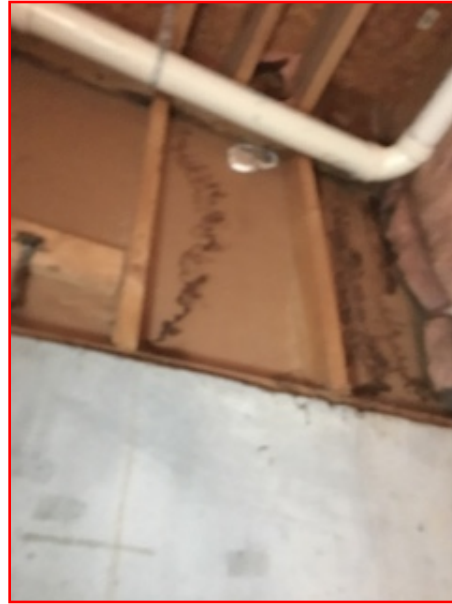
The wall shows active water leaks throughout the basement.

34) The wall shows active water leaks throughout the basement.

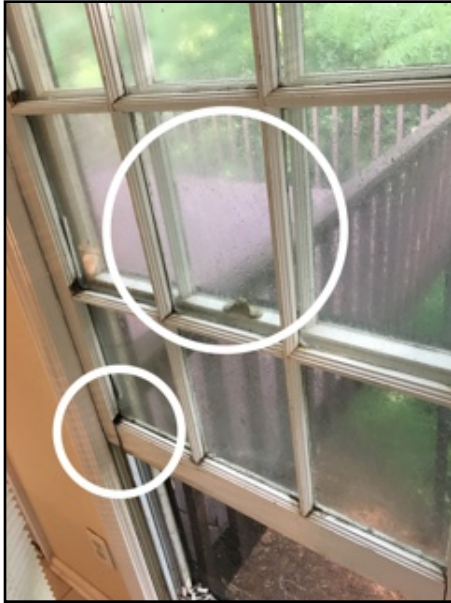
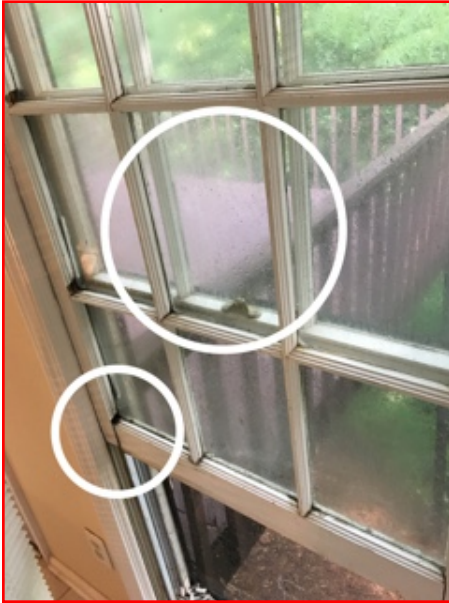
The kitchen window has cloudy glass indicating lost thermoseal.

35) The kitchen window has cloudy glass indicating lost thermoseal.

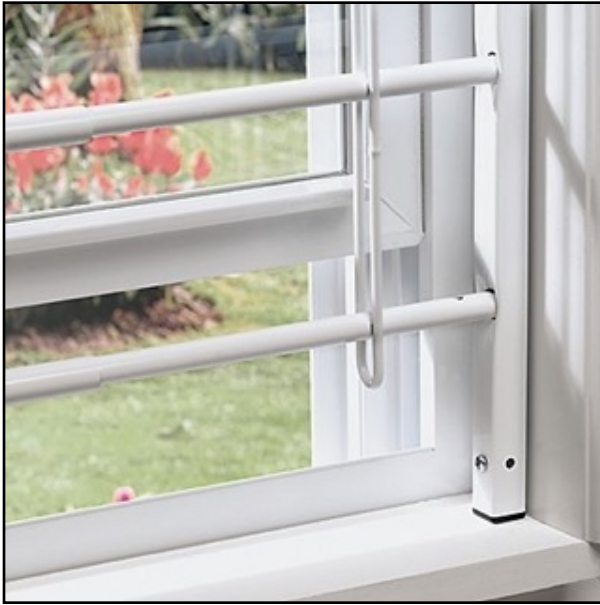
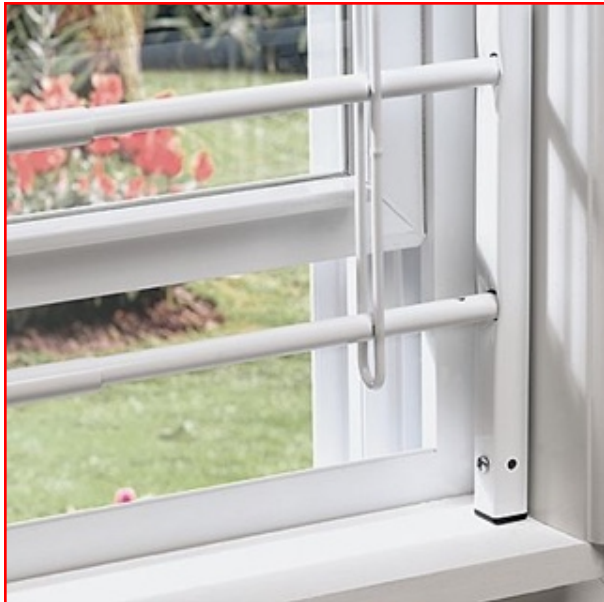
Recommend installation of Child safety window Guards. Many windows throughout the house are at floor level and can be a hazard for small children.

37) Recommend installation of Child safety window Guards. Many windows throughout the house are at floor level and can be a hazard for small children.
